Version: V0.0.0
Author(s): BQ
Revised by: Jon Goitia
Effect date: 18/05/2018
Project: Hephestos 2

This guide aims to help customers who have assembled a BQ Hephestos 2 get the maximum out of their 3D printer and troubleshoot any issues with the auto - levelling feature.

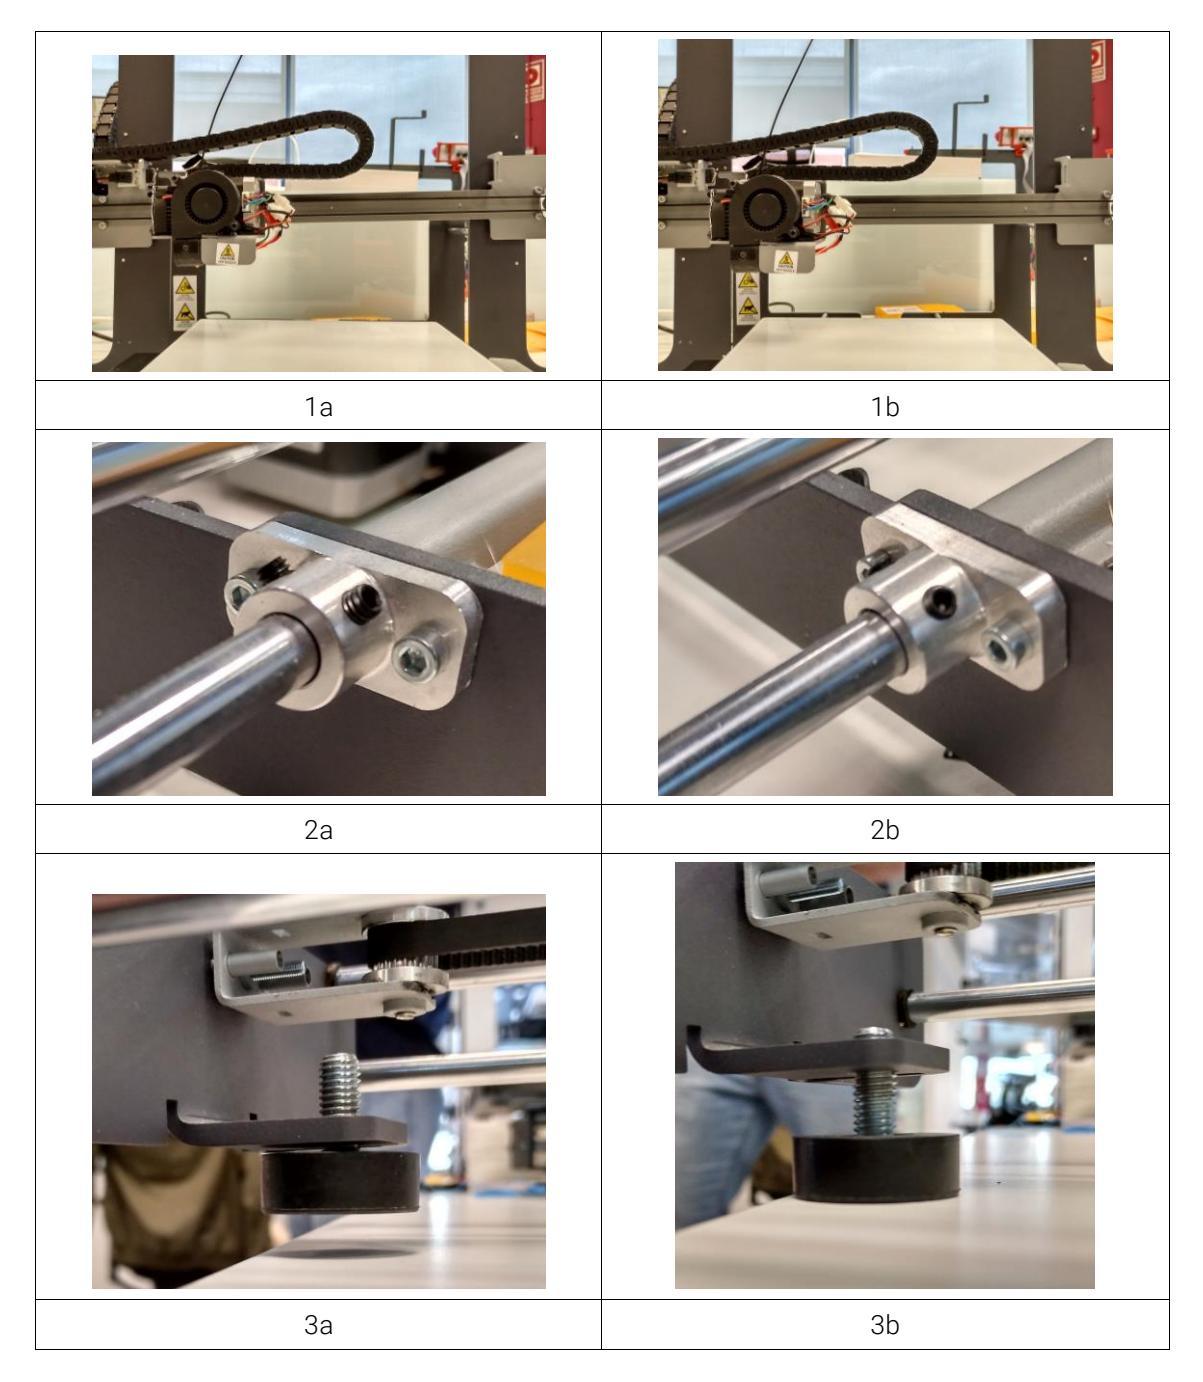
- 1) Make sure the X-axis is parallel to the print bed. Picture 1a shows an X-axis that is not leveled because the right side is higher than the left. Adjust the height of one side by turning the Z-coupling while holding the other in place (picture 1b).
- 2) Adjust the set screws that hold the Y axis to the printer frame (picture 2a). Do not use excessive torque but make sure they are firmly in place (picture 2b).
- 3) Adjust the rubber foot so the front of the printer is properly supported. Start with the foot above its normal position (picture 3a) and screw it in until you feel the weight that it is holding (picture 3b)

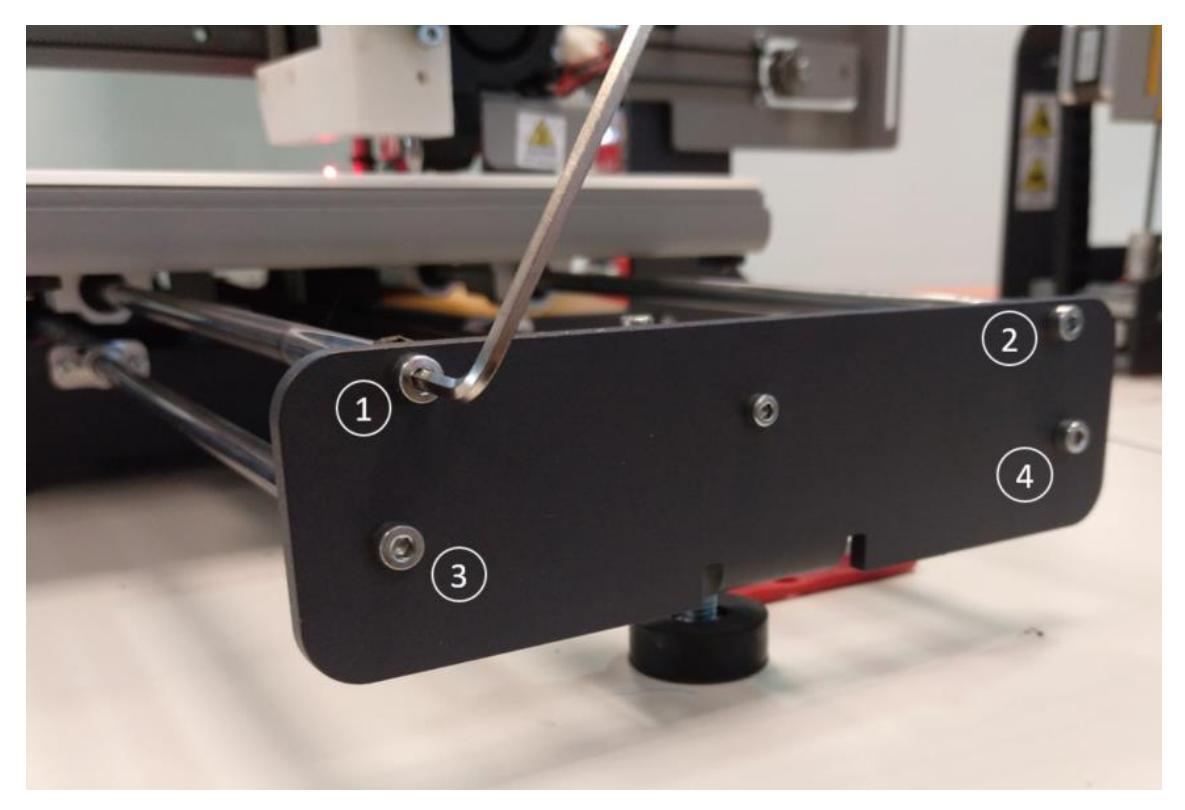
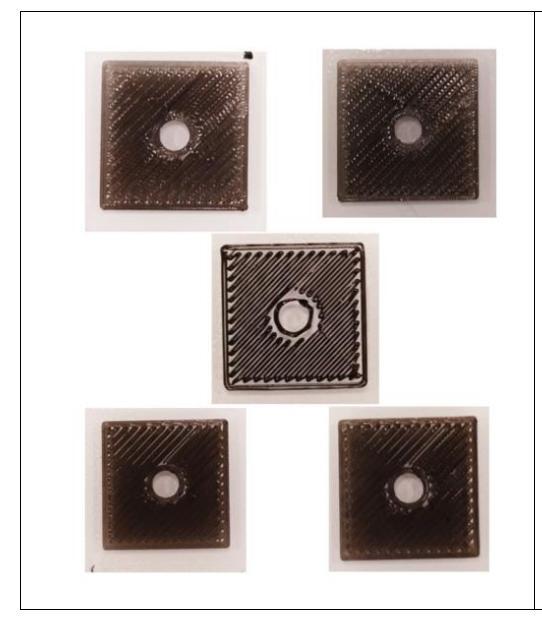
Test result:

The most common mechanical issue is over-tightening the 4 bolts that hold the Y-axis in the front bracket. This warps the Y-axis linear guides and causes the bed to move in a non-planar fashion. To solve this issue, follow these steps:

After loosening the front bolts, the test Gcode shows that the top-left and the bottom-right corners have been fixed and have proper adhesion.

The center square still seems to be too high, so further tweaks are necessary.

- 1) Unscrew the 4 bolts in the front bracket until they are loose (not creating any pressure against the bracket)
- 2) Jiggle the bracket in both directions so the linear guides have a chance to settle in a new position.
- 3) Retighten the bolts without any pressure, so you can turn them by hand

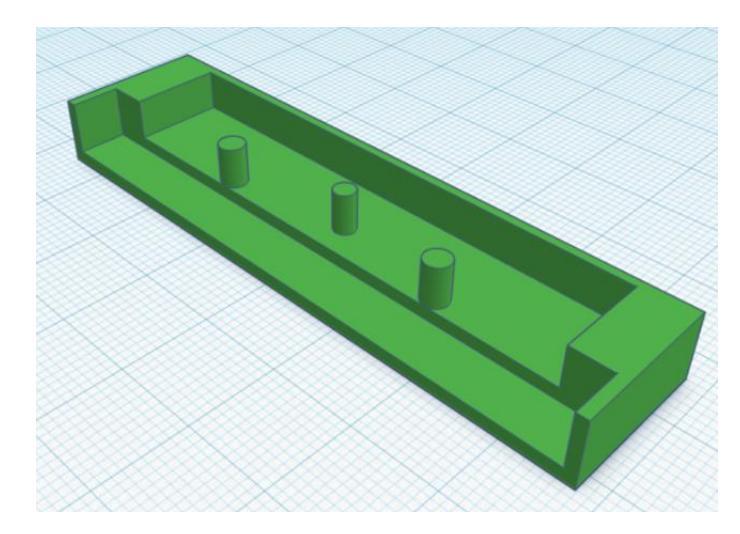
If the bed is not sitting flat on the Y-axis, putting pressure on the tabs to hold it in place could cause the bed to warp slightly and cause issues in the center area of the bed.

The bracket holds the side wings of the print bed and fits in the holes of the original system

A solution to this problem is to print <u>this part</u> as an alternative. It holds the bed in place without pressure from the top, using the same holes as the original system.

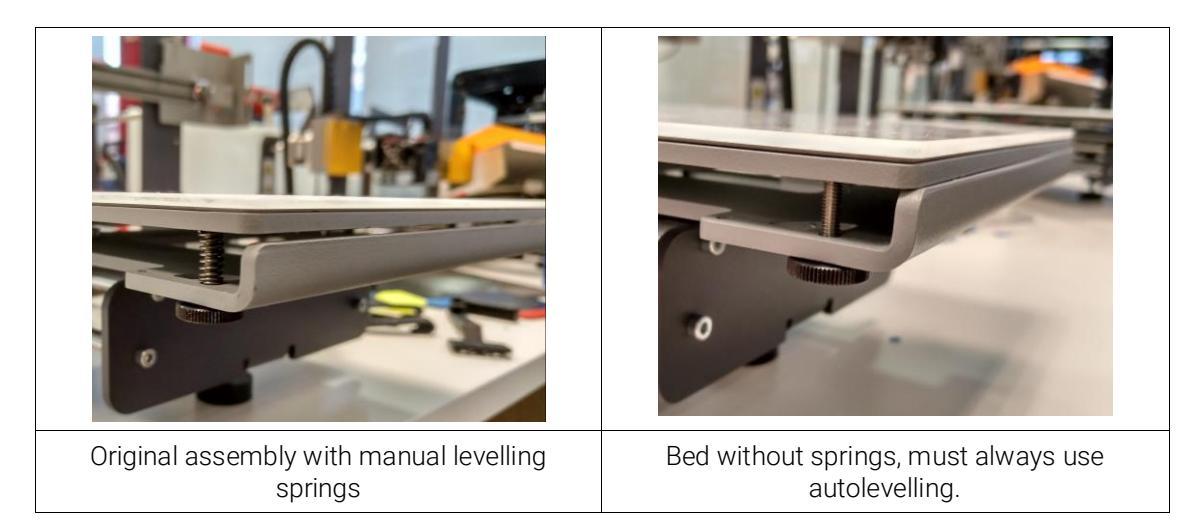
In case the manual levelling is not working correctly due to a problem with the springs, it can be easily removed to have autolevelling only. In this case, the bed is supported by the lower sheet metal instead of floating a few millimeters above it. This can help with consistency issues and can easily be reversed if it does not have the desired effect.
